Shaw House and Church Conservation Area Management Plan

A report by LUC and Keevil Heritage Limited

Final Report
March 2020

Client: West Berkshire Council

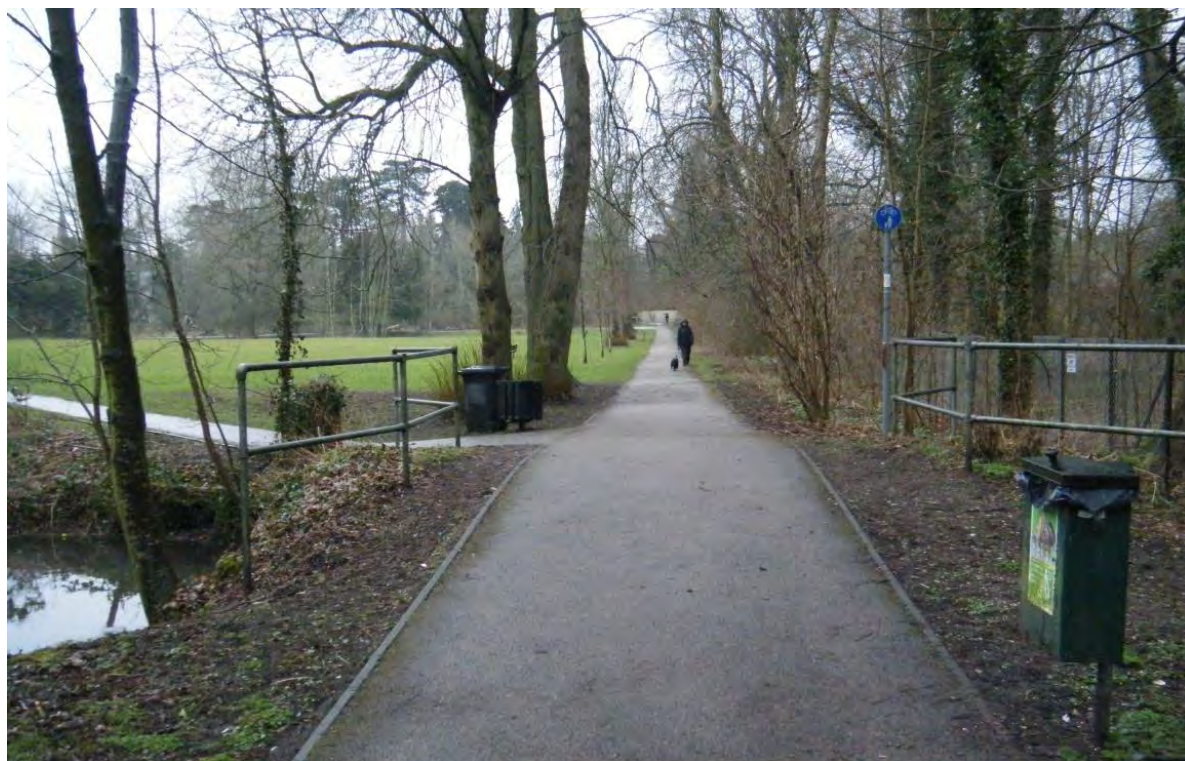
Figure 3.5 20th Century trees along the remnants of Andrews 18th Century Lime tree lined avenue.

- 3.34 Other improvements Andrews intended to undertake at Shaw House included the completion of a tree-lined drive in the grounds leading from Bath road to the house crossing the River Lambourn by a new bridge¹⁵. The tree planting to the south of Shaw House included clumps and avenues as well as instructions given for rhythmic planting. The new carriage drive was created off the London turnpike road and, apart from at the ends, where recent development has encroached upon its track, the alignment is still represented by the regular spacing of trees along the edge of the modern park beside the River Lambourn.

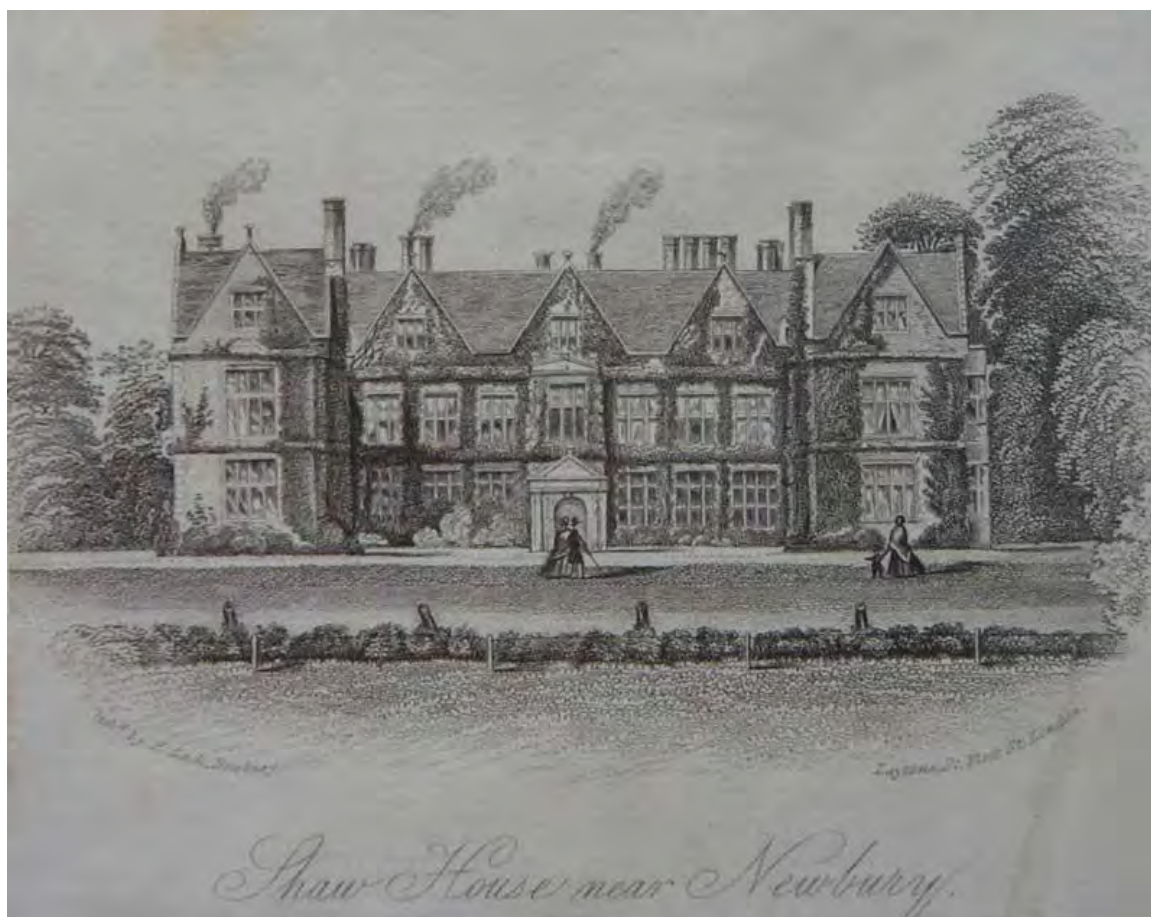
Figure 3.7 Engraving by Laytons of Shaw House 18th Century¹⁹

- 3.38 The earlier formal gardens are still evident on the Ordnance Survey Drawing of East Ilsley of 1821 by W. Stanley¹⁷ however the gardens were soon replaced by informal groves of tall conifers which framed the view of the house¹⁸. The informal gardens can be seen in Figure 3.7 in an engraving by Laytons. The front façade is bordered by a number of shrub beds with the drive leading from the west to the front door. The lawn sits within the foreground of the engraving, setting Shaw House in what appears to be a very luxuriant garden.

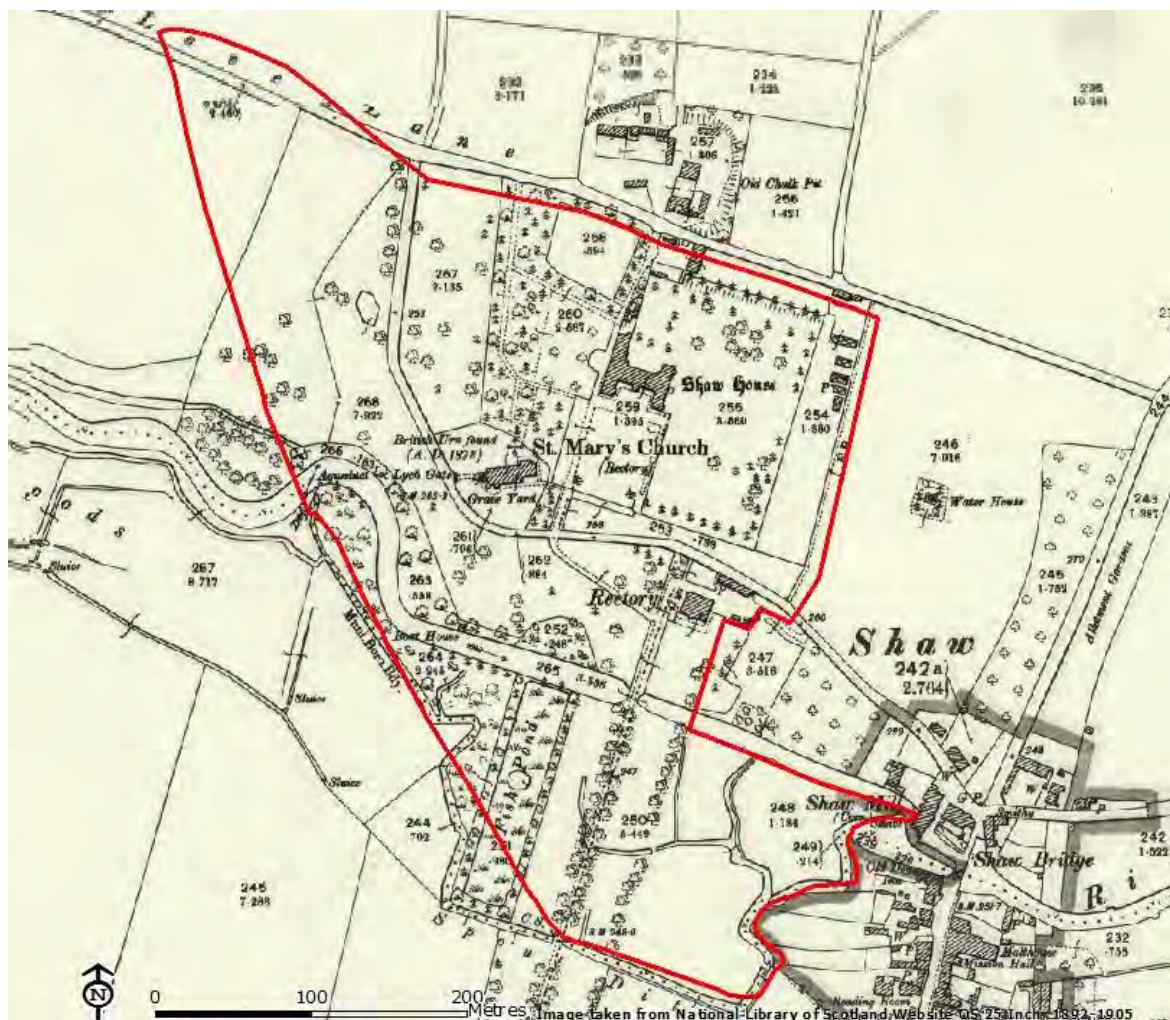
Figure 3.8 First Edition Ordnance Survey Berkshire XXXV 1883 ©NLS (2018).

- 3.41 The 1st edition Ordnance Survey shows a square of lawn surrounded by a wide border to the south of the House. The garden became very typical of its era and was planted with a selection of exotic trees, shrubberies, herbaceous borders and elaborate bedding displays. Subsequent snapshots show the development of small but elaborate flowerbeds and a pergola along an adjacent path; these have all since disappeared. By the time the 1st edition 25" OS map was surveyed in 1878, the stable yard and associated service buildings had been demolished and a new wilderness garden is shown to the west of the house²⁰.

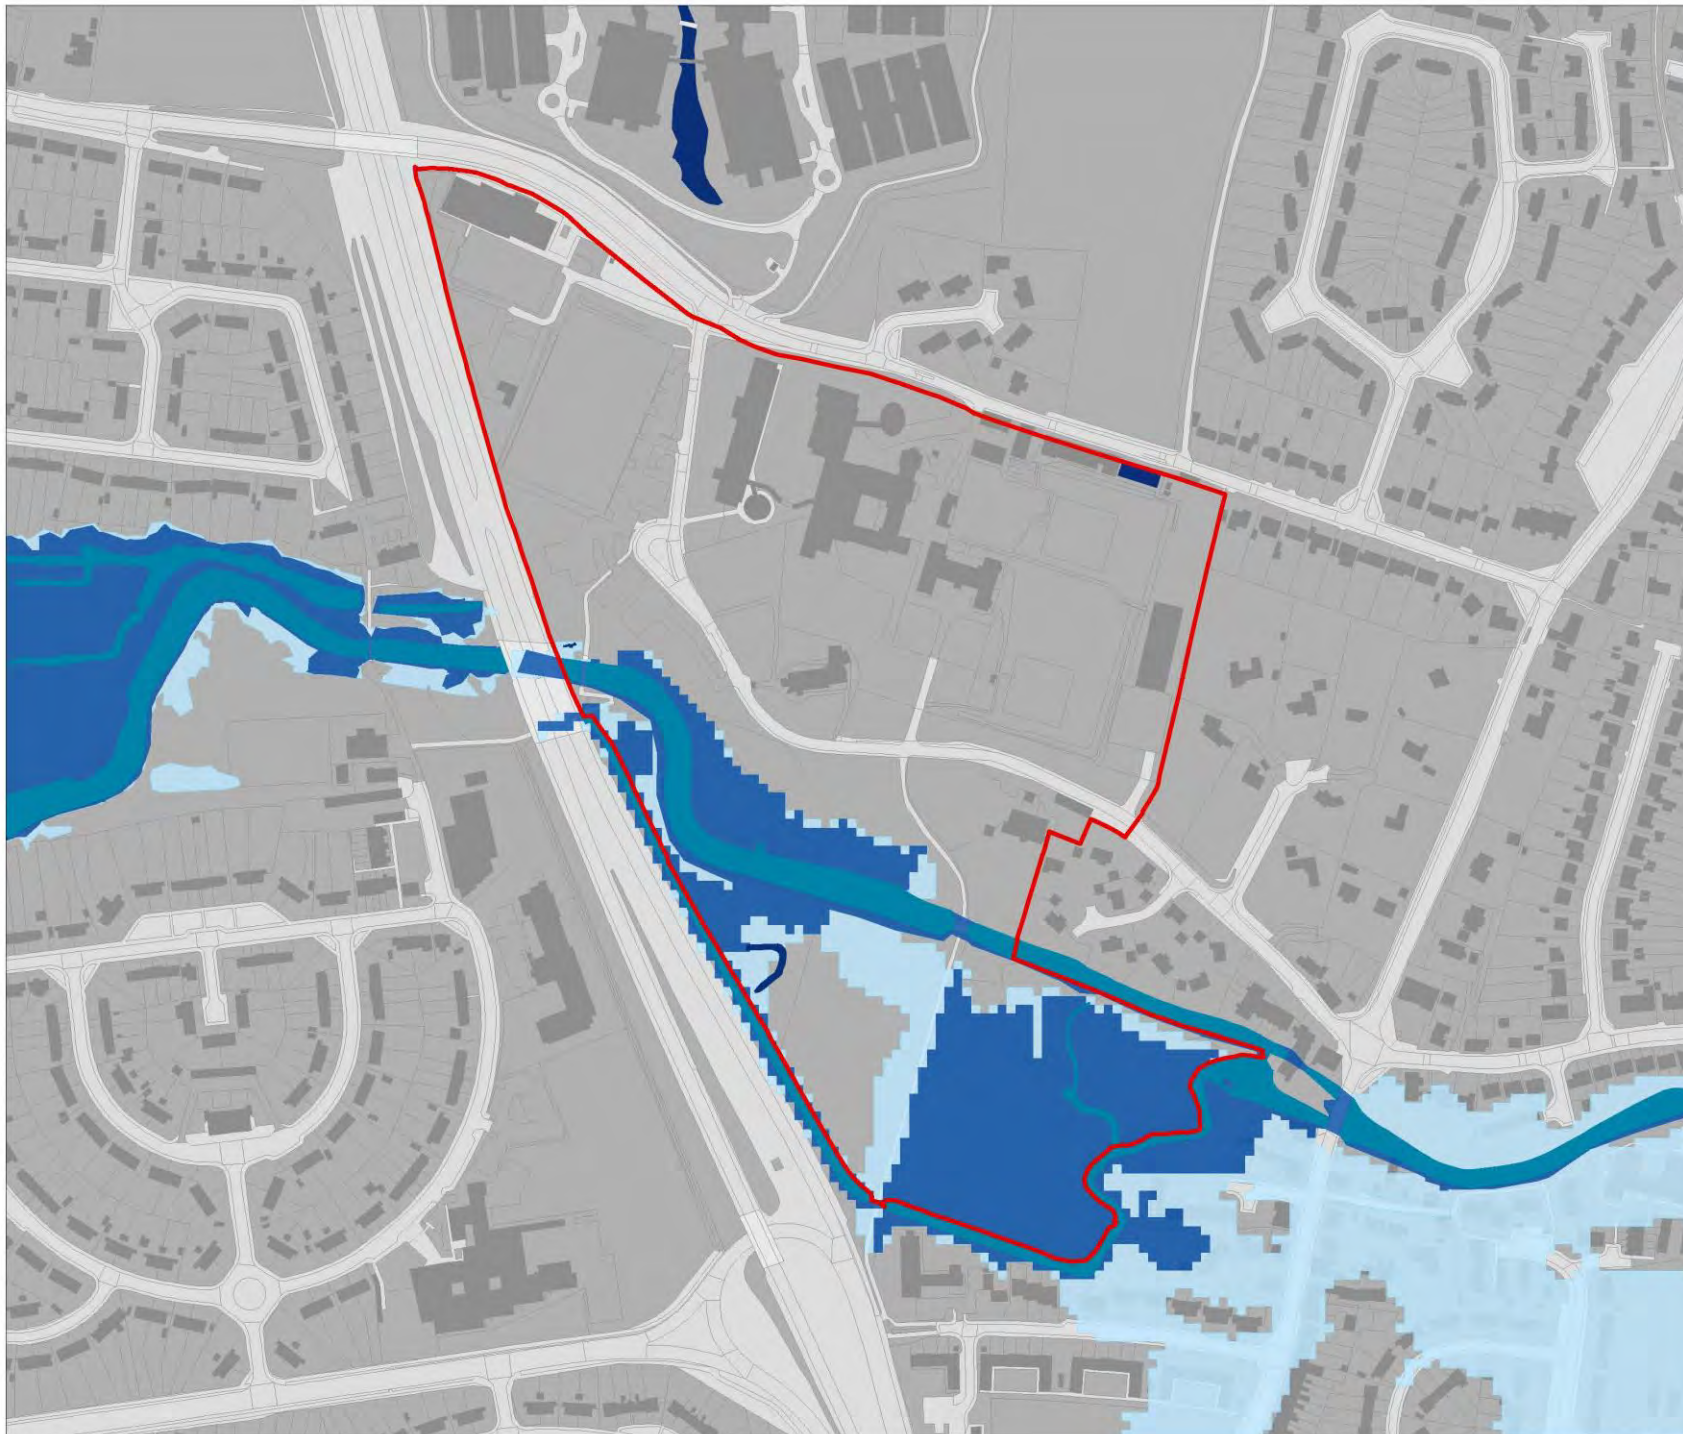
Figure 4.5: Recorded Hydrology

- Shaw Conservation Area
- River Lambourn (OSMM)
- Other Waterbodies (OSMM)
- Flood zone 3
- Flood zone 2

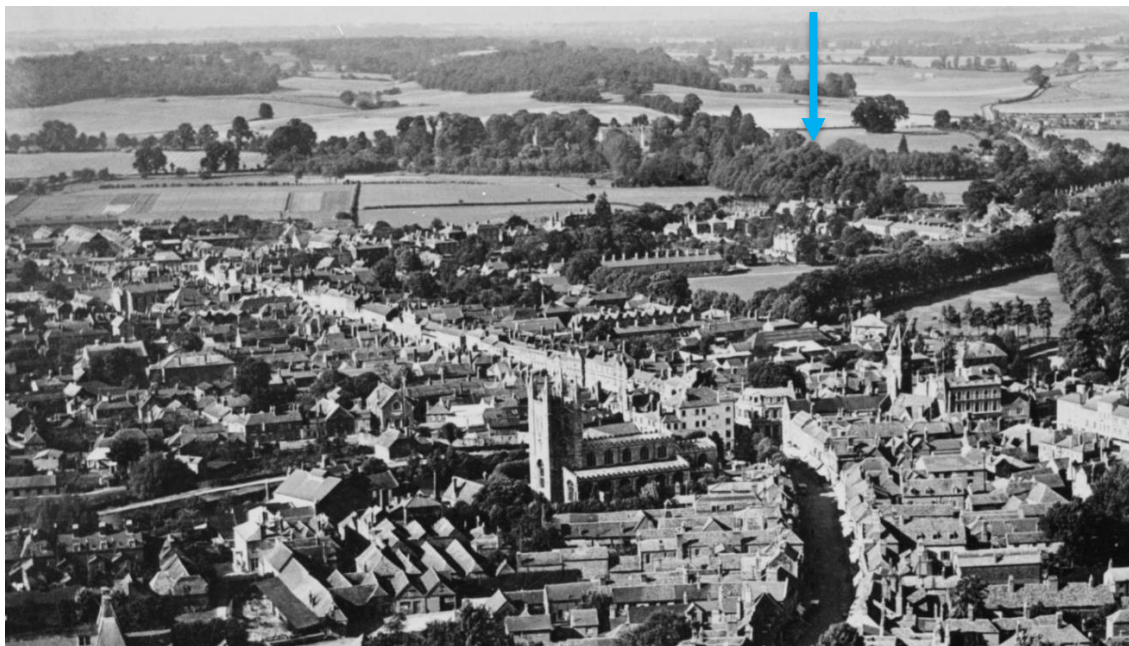
Figure 5.2 Part of a photograph taken in July 1924 of Newbury looking north-east³¹.

- 5.27 Figure 5.2 shows Shaw House and the Church of St Mary can be seen in the centre distance. The most striking feature is the triple line of trees lining the former canals running south from the River Lambourn – arrowed.

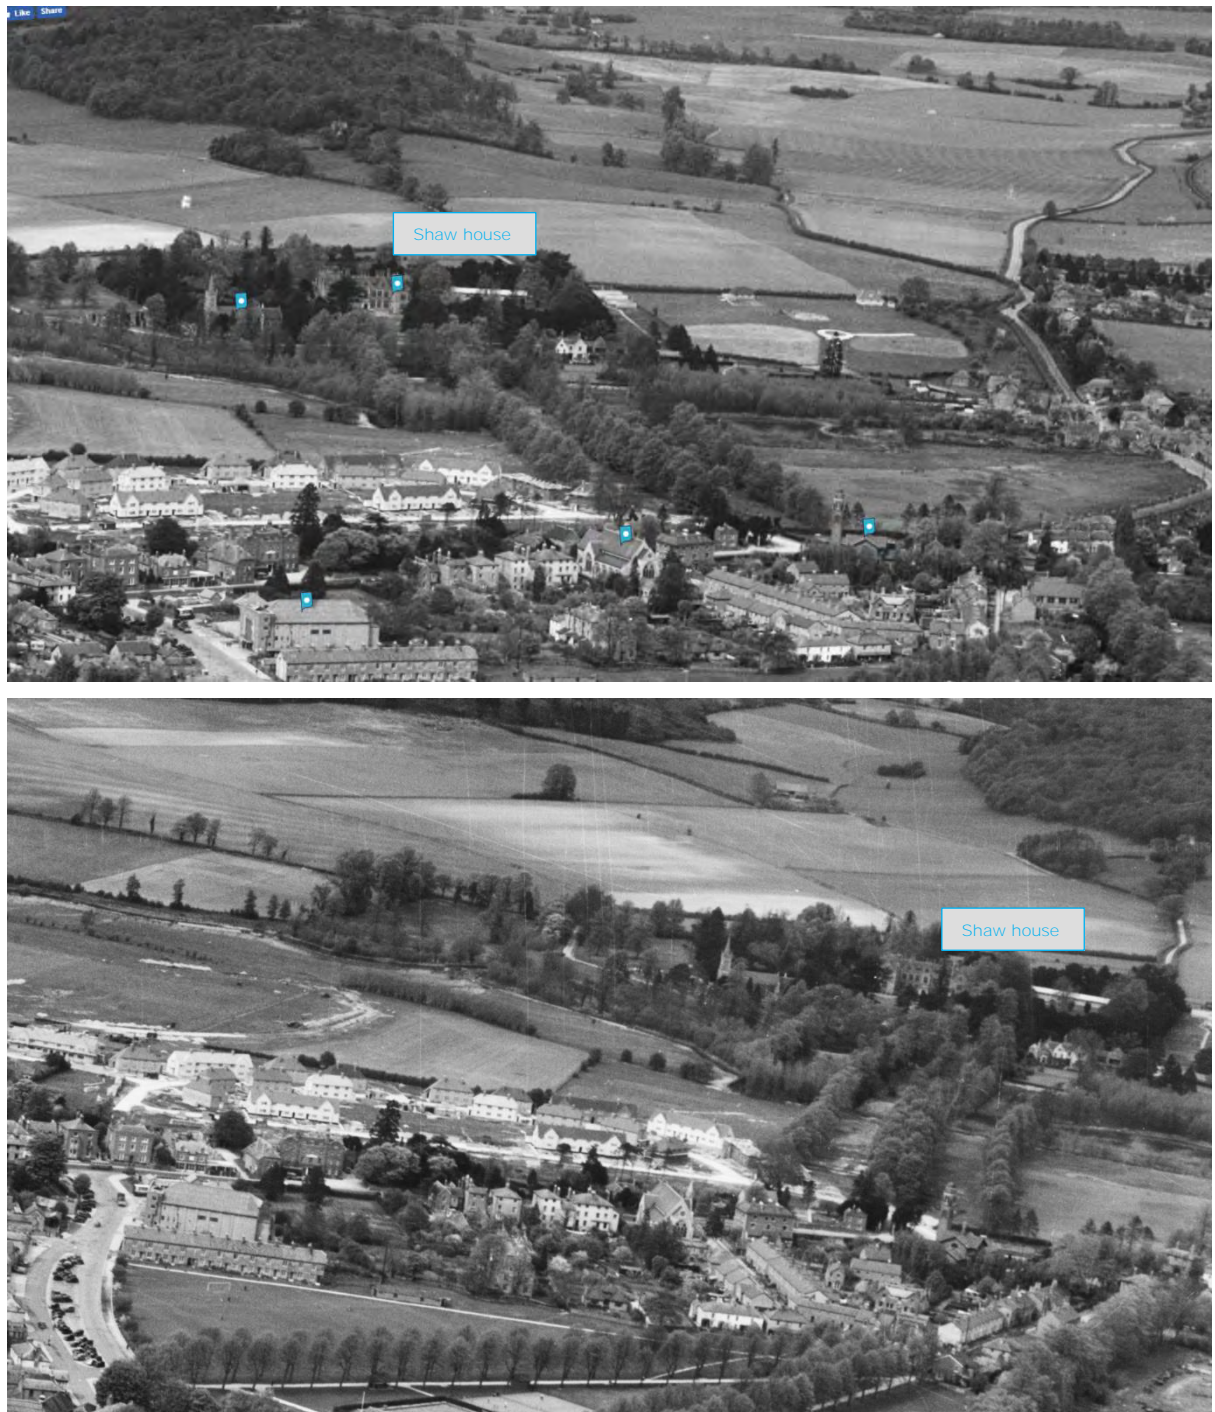
Figure 5.3 These are extracts from a pair of photograph taken in April 1948, again with the centre of Newbury as the main focus but with Shaw in the background^{32 33}.

³³ Within Figure 5.3 the triple line of trees are even clearer in view, as are the water meadows. The upper image also shows the start of development on the open ground where Shaw House's well house used to be, to the east of the kitchen garden. Both photographs also show the gradual encroachment of urban expansion as Newbury began to engulf Shaw.

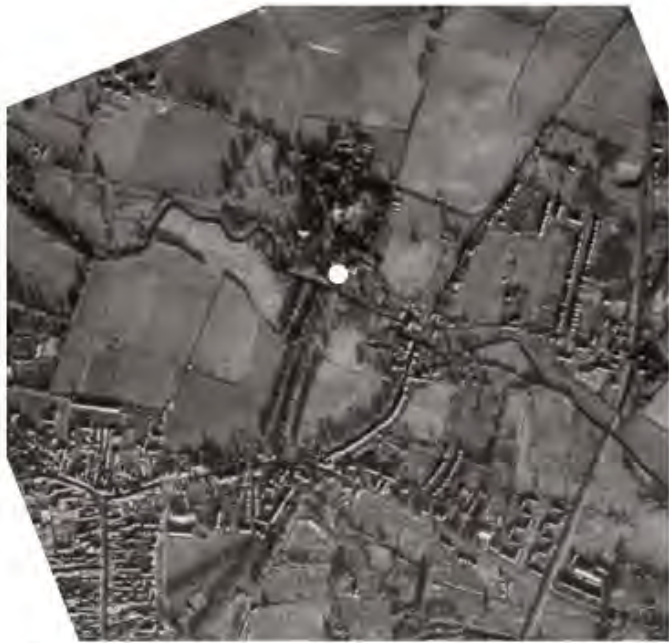
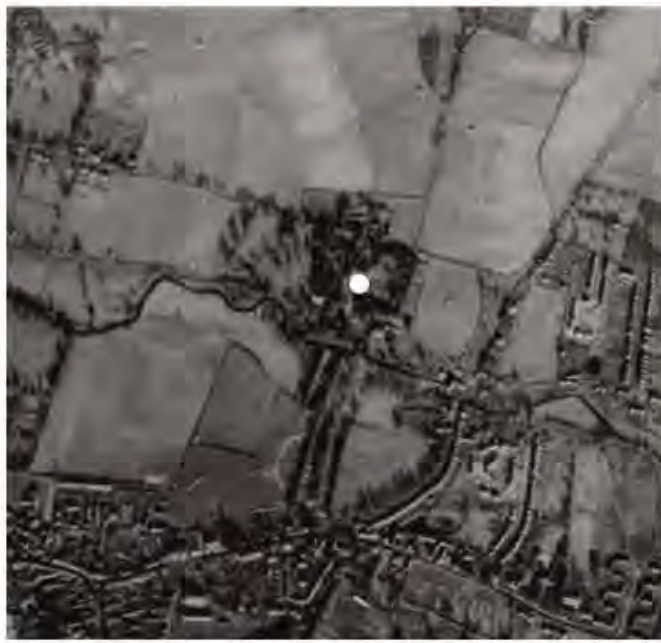
Figure 5.5 Vertical aerial photographs taken on 2 December 1943.

Figure 5.6 Vertical aerial photographs taken on 18 January 1947. Refer to Figure 5.3.

Figure 5.5 and 5.6: Shows new housing starting to encroach as far as Shaw – but the house and grounds are still quite distinct. Note the tree avenues to Bath Road, and the small mound where the well house stood – contrast this with the previous oblique photographs taken only one year later. (Historic England Archive photos US/7PH/GP/LOC90 5017 and RAF/CPE/UK/1936 559 4362)

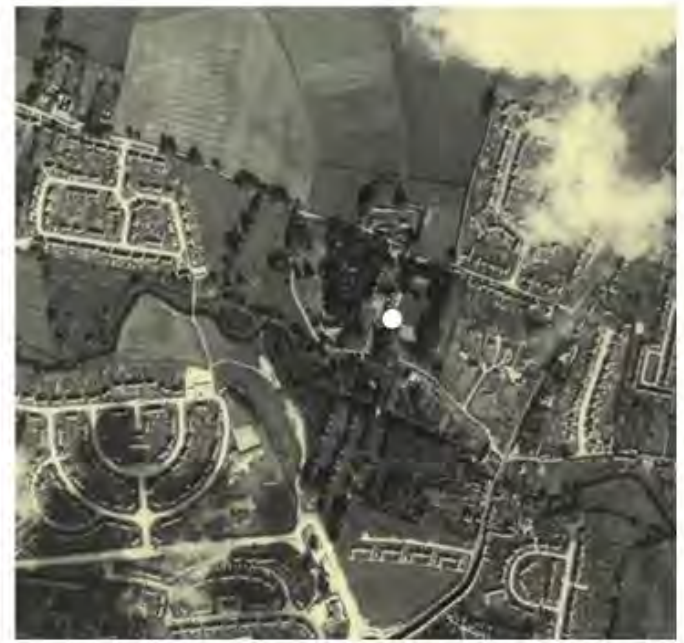
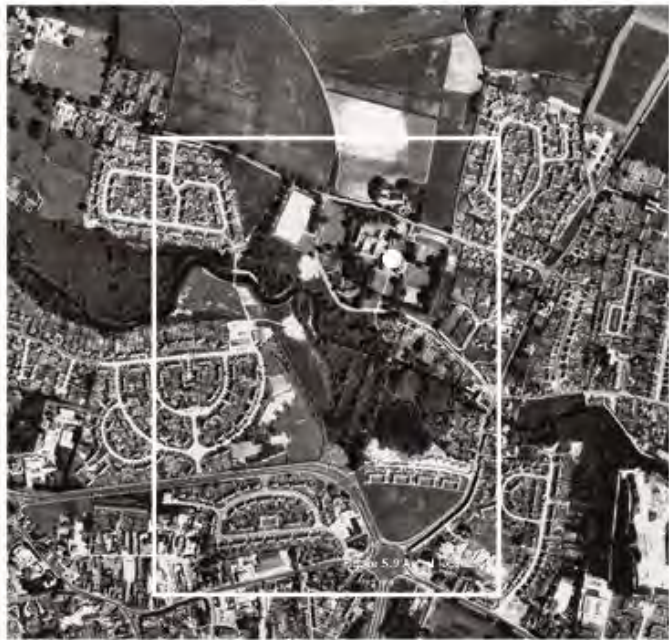
Figure 5.7 Vertical aerial photographs taken on 26 September 1958.

Figure 5.8 Vertical aerial photographs taken on 13 June 1967.

Figure 5.7 and 5.8: Building on the well house site has now begun, and the new school on the manor area was built between these dates. Extensive new housing had been built to the east and west. (Historic England Archive photos RAF/543/403 103 and RAF/543/3869 642).

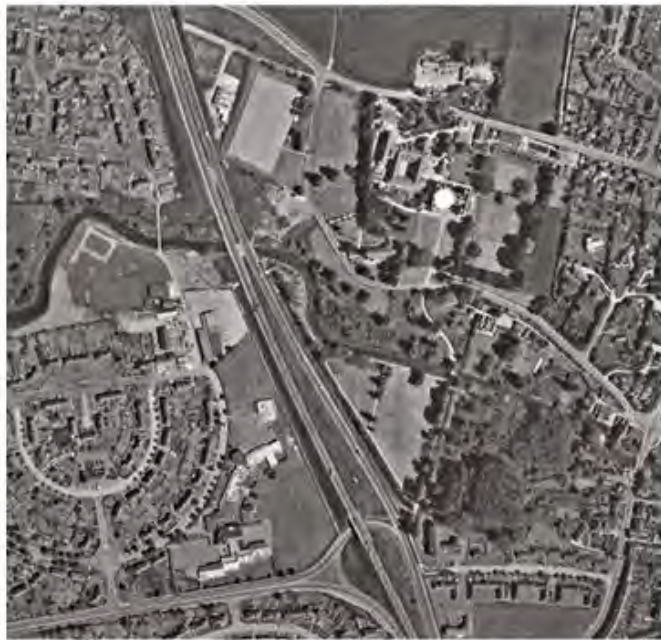
Figure 5.9 Vertical aerial photograph taken on 26 May 1978.

Figure 5.9: Showing the extent to which building of the A339 link road cut Shaw House off from Donnington and Newbury, while also cutting through the parkland and especially the former canal area (the Spout Ditch had to be diverted). The old tree avenues had also all but disappeared – but the water meadows to the east seem to have orchard-style planting. (Historic England Archive photo OS/78056 15).

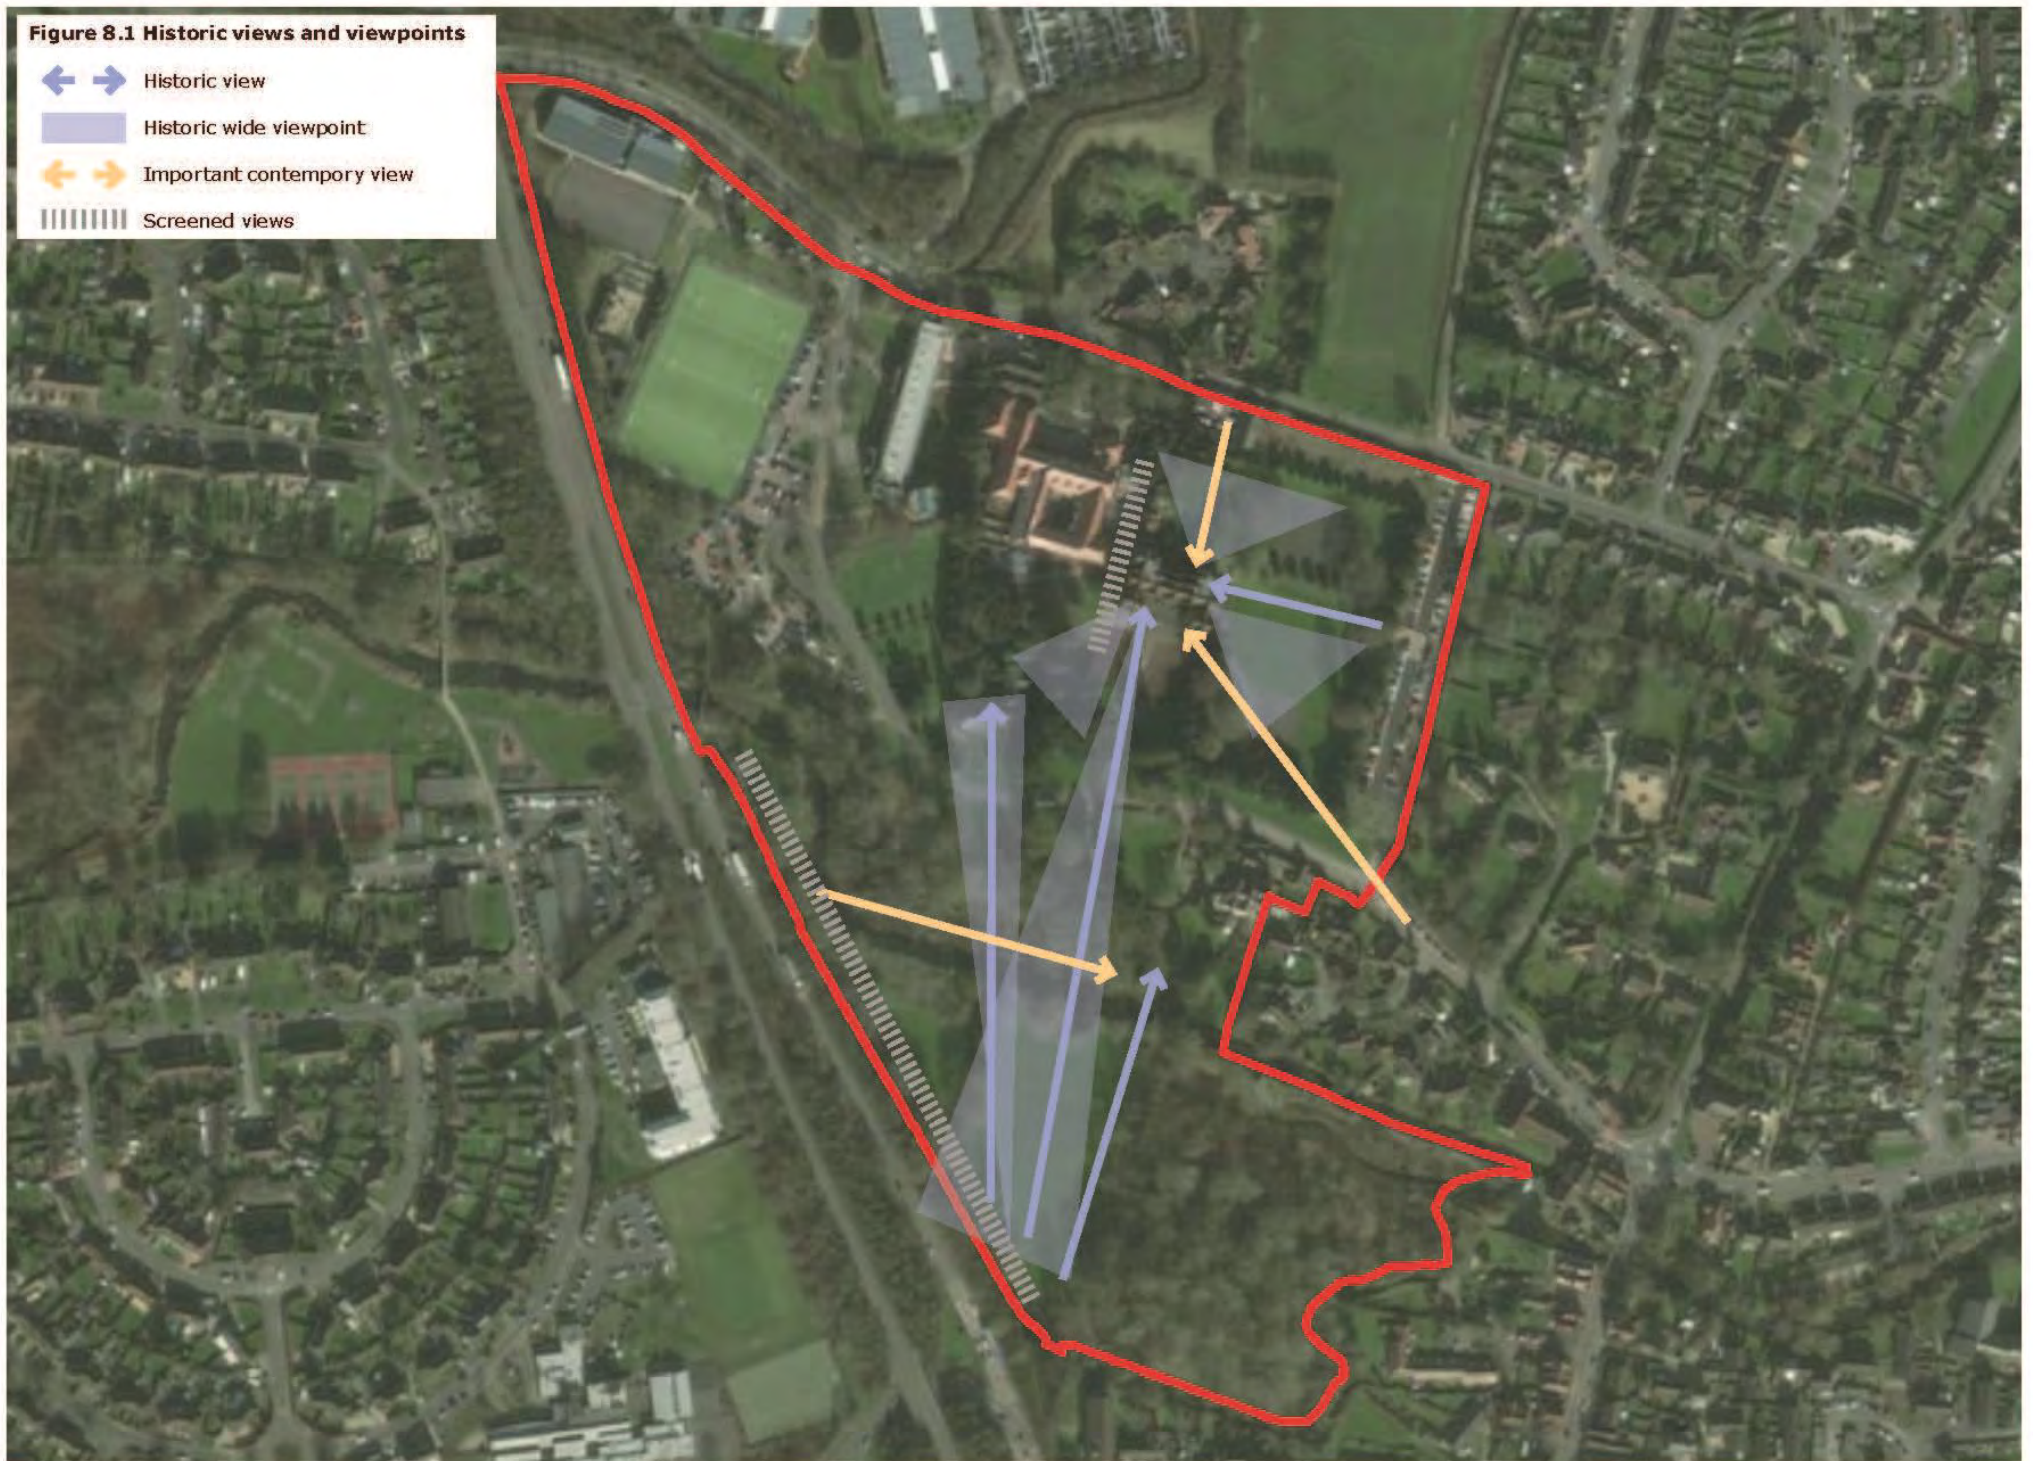
Figure 8.1 Historic views and viewpoints

- ← → Historic view
- Historic wide viewpoint
- ← → Important contemporary view
- Screened views

- 8.11 The most important of the historical views were those from Bath Road along the canal to Shaw House [1] (see Figure 8.2), along the tree lined avenue [2] and drive and from Bath Road to St Marys Church [3]. Other important internal views included those from Shaw House out over the formal historic gardens [4, 5].

- 8.16 Figure 8.1 locates some of the more prominent views at Shaw House.

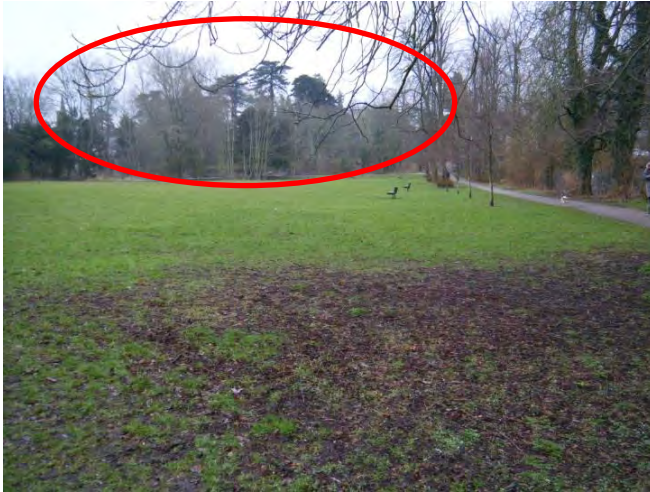
[View 1] View from Bath Road to Shaw House along the canal. All evidence of a connection between the park and Shaw House is now lost.

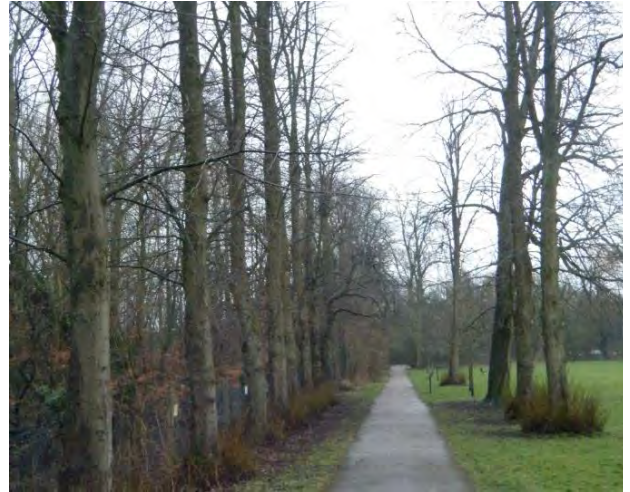
[View 2] View along the tree lined avenue. The view remains intact and is fairly formal but there is no interpretation summarising the historic importance and linking the park to Shaw House.

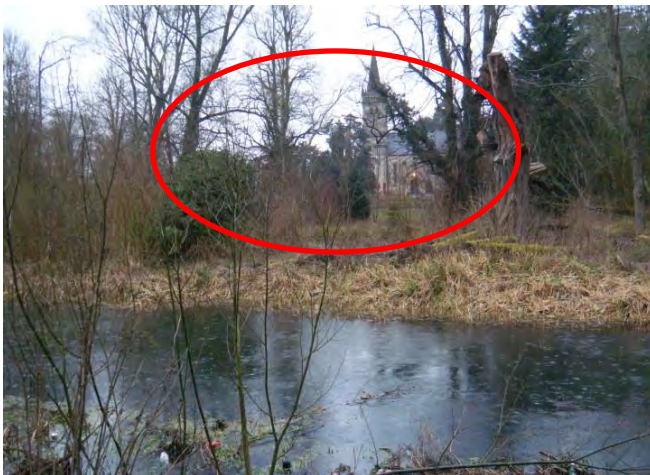
[View 3] View from the park to St Marys Church is fairly fragmented with no historic links evident.

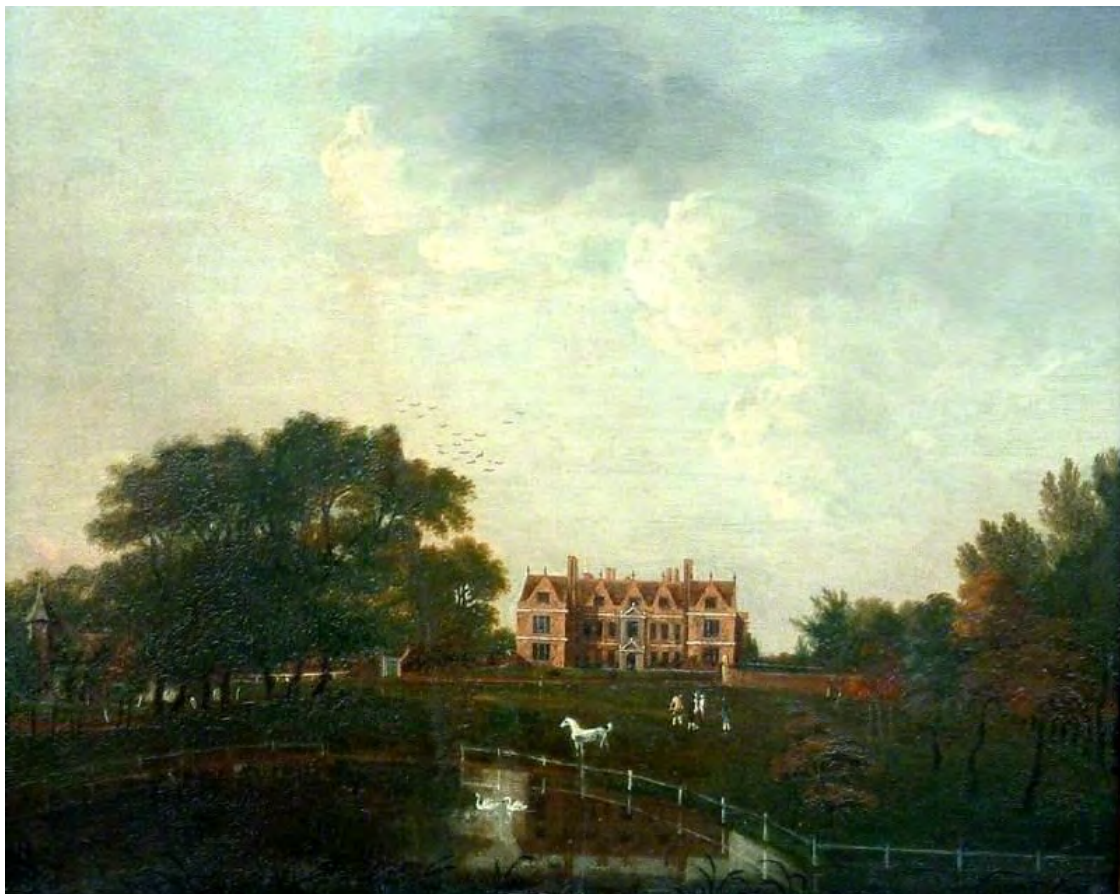
Figure 8.3 John Collins Landscape of Shaw House 1736 © West Berkshire Museum

- 8.20 The John Collins painting of the landscape of Shaw House in 1736 is held by the West Berkshire Museum, see Figure 8.3. The painting is set from the canal basin looking north towards Shaw House. Within the painting you can see the gardens bounded by the brick wall which remains today. The canal basin is aligned with the front of Shaw House; however this important view is now largely concealed by woodland that has developed on the northern bank of the River Lambourn.

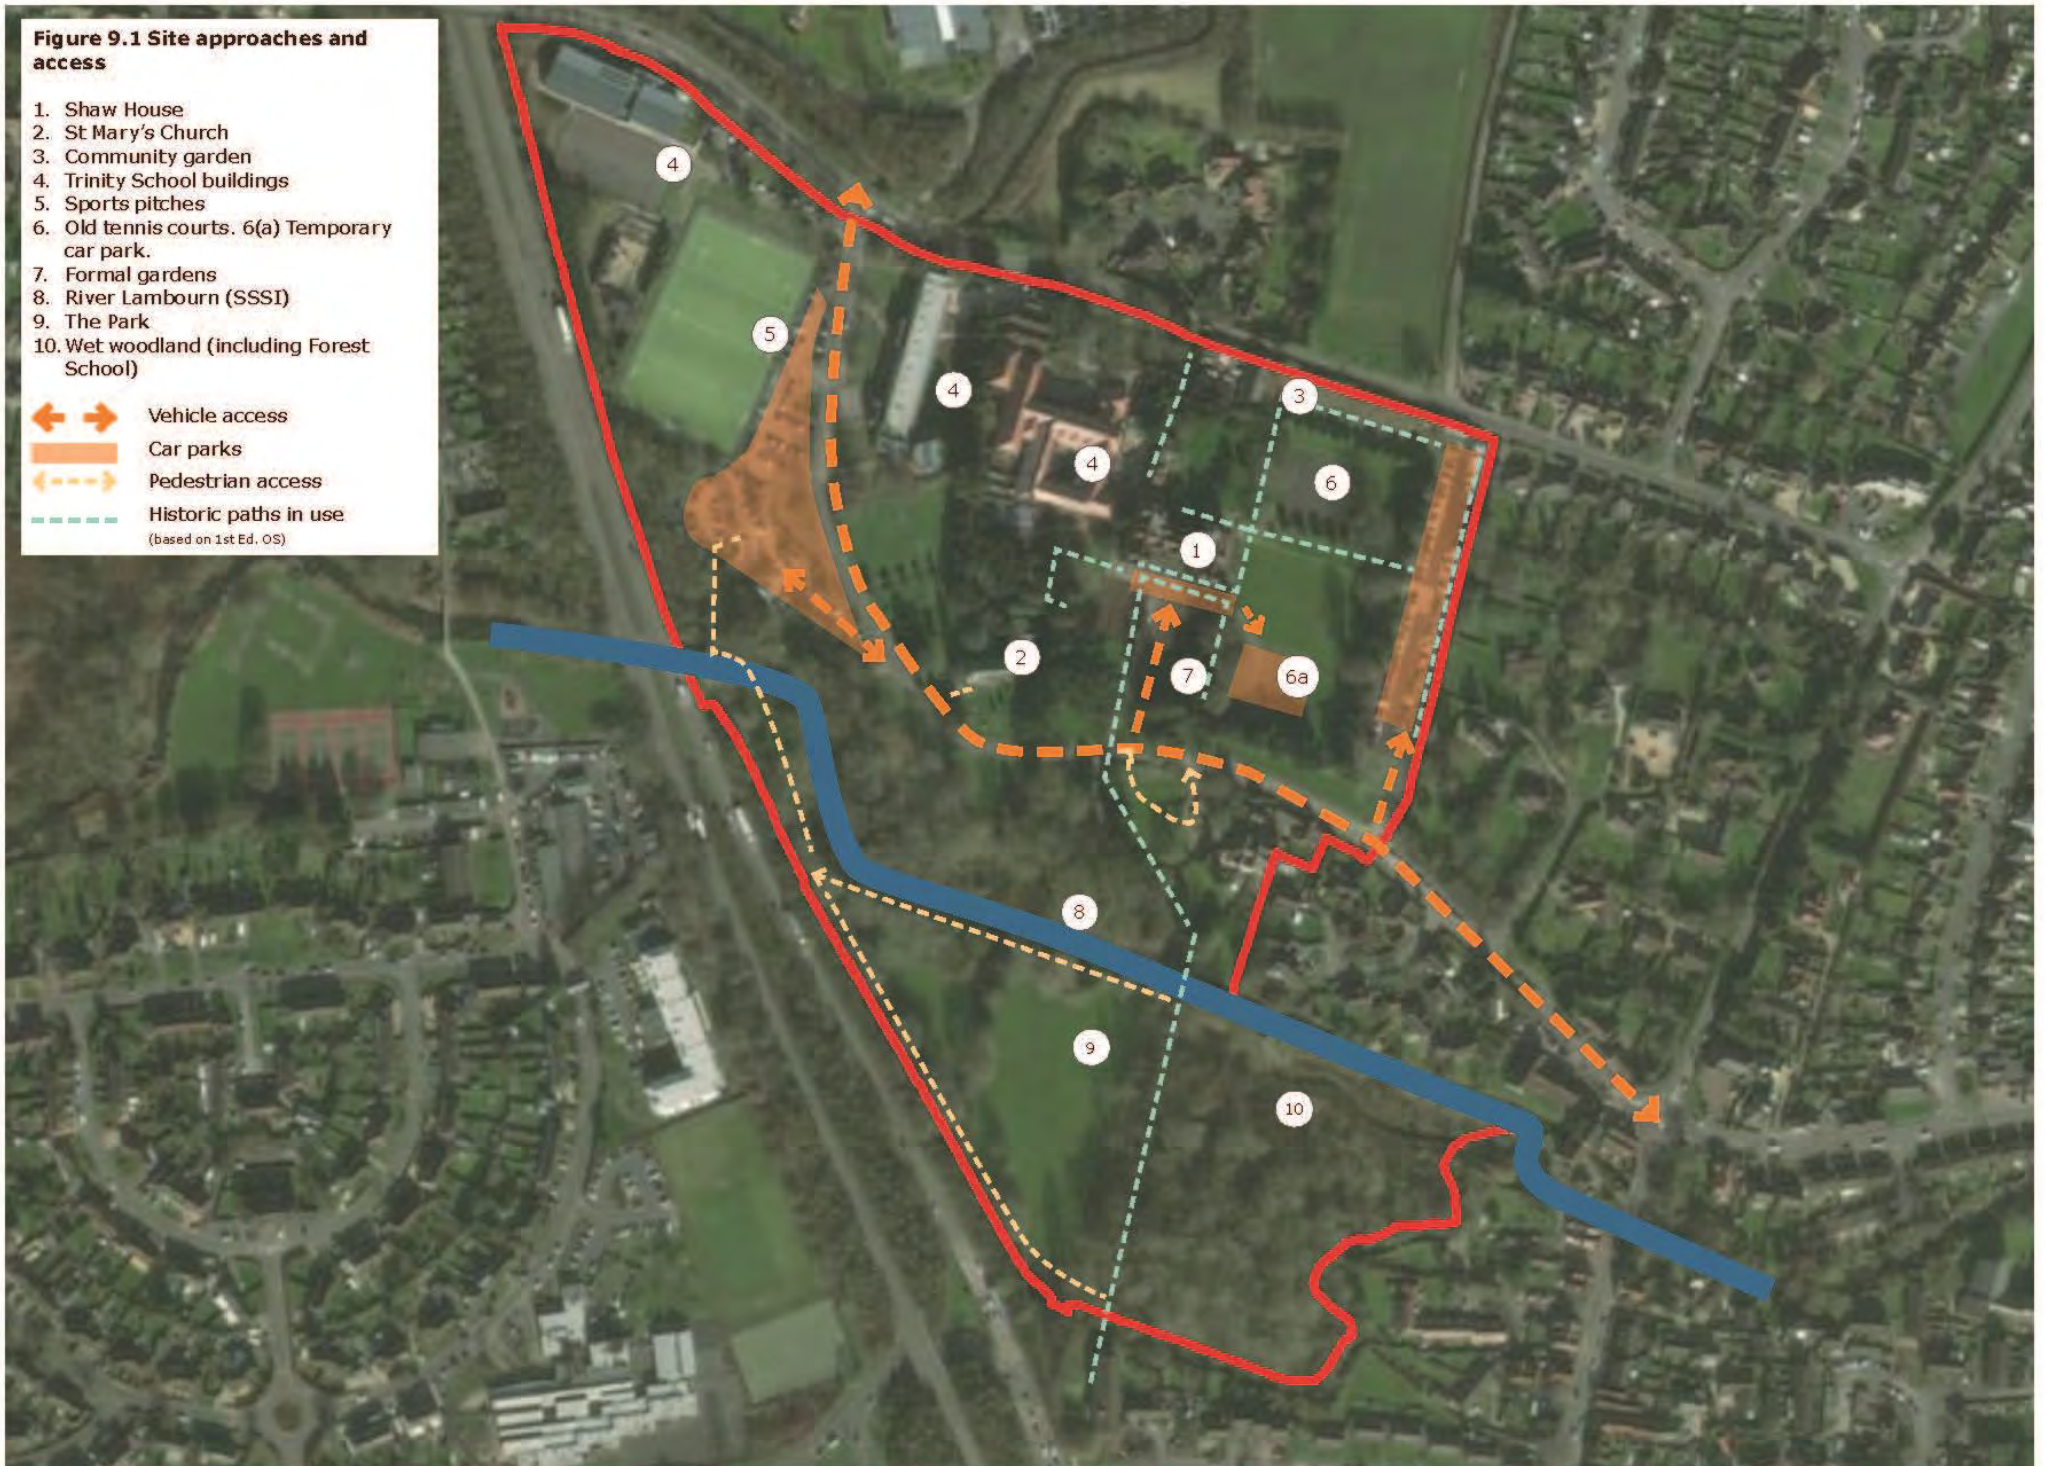
1. Shaw House
2. St Mary's Church
3. Community garden
4. Trinity School buildings
5. Sports pitches
6. Old tennis courts. 6(a) Temporary car park.
7. Formal gardens
8. River Lambourn (SSSI)
9. The Park
10. Wet woodland (including Forest School)

- ← → Vehicle access
- Car parks
- ← - - - - - Pedestrian access
- - - - - Historic paths in use
(based on 1st Ed. OS)

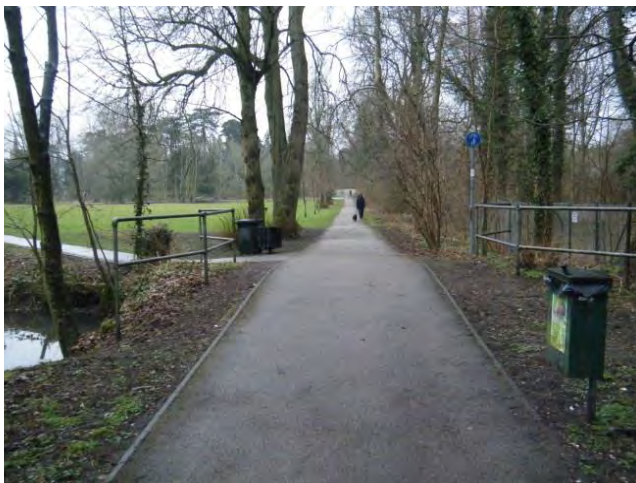
Image taken from the southern end of the tree lined avenue looking north.

- 9.11 The avenue is one of the key visible historic features, dating back to the 18th Century landscape design by Andrews, but has been replanted more recently (Phase IX 1939 onwards) with *Tilia x euopaea* (common lime). The avenue has become less prominent than it perhaps was with the proximity of vegetation encroaching from the woodland to the east and the loss of important views towards Shaw House. As a result it has lost the formality of what once would have been the main drive to Shaw House.

- 9.12 The path is surfaced with tarmac and is approximately 2 metres wide. The path is shared with cyclists which may put off some user groups dependent on the speed of the bicycles. There are limited seats available along the walk potentially making the area less accessible for some user groups. In addition there is limited directional signage within the area and some areas of the path are showing signs of wear and tear, particularly along the path edges.

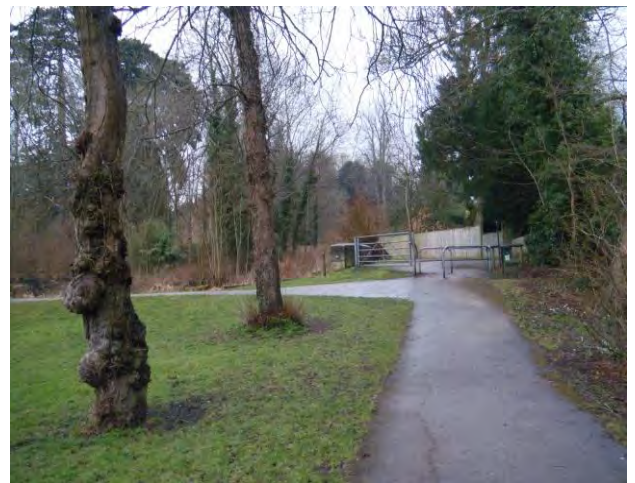
Image taken from the northern end of the tree lined avenue looking north.

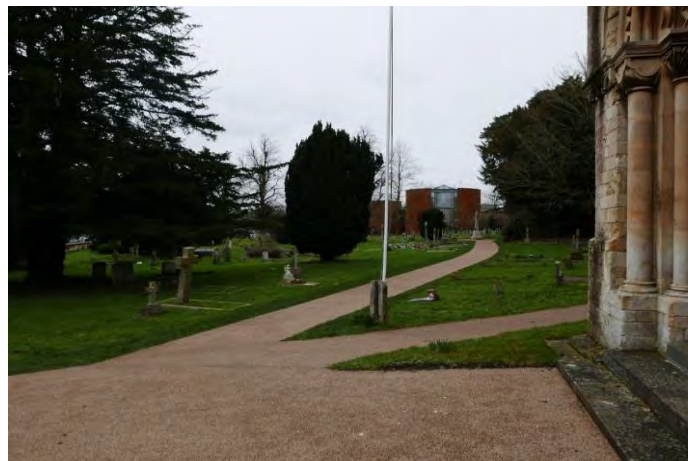
Recently renovated paths using self-bound gravel.

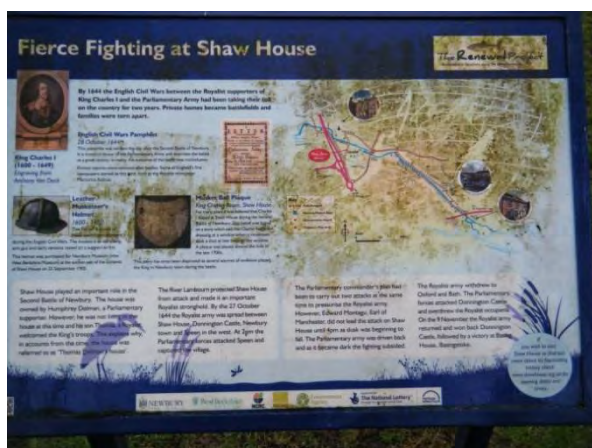
Lectern interpretation panels located along the tree lined avenue.

- 9.34 Archaeology is an area where existing interpretation is completely inadequate. There is little or no information across most of the site to highlight its rich legacy of buried and standing archaeology. Exposed fabric and interpretation boards at Shaw House revealing and explaining discoveries made during the refurbishment project provide excellent examples of what can be achieved. Something similar could be extended to the grounds: the boundary walls, garden archaeology and the smaller buildings within the curtilage currently receive very little attention but offer fascinating insights into how the wider site developed and was used. The Civil War is an obvious theme, and to some extent its history is interpreted in the wider landscape – but not the archaeology. Similarly, the remarkable designed landscape to the south of the House and beyond the River Lambourn is partly described in boards on the parkland area to the south of the river, but these are in poor condition and need to highlight the archaeological potential much more.

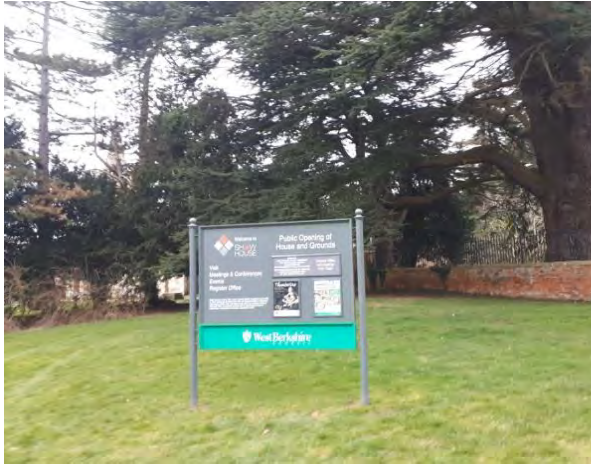
Lectern interpretation panel located along the south lawn of Shaw House.

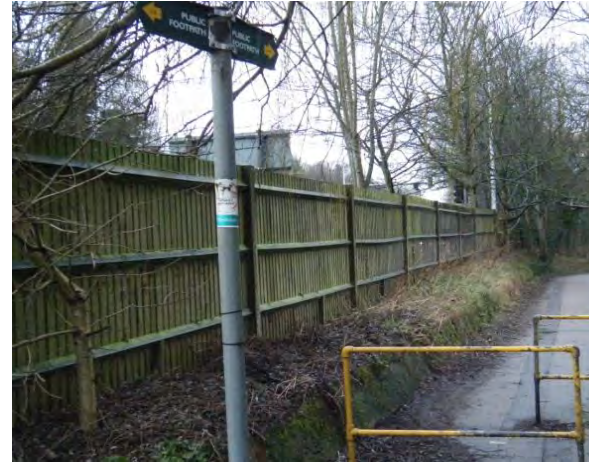
Waymarked Public Rights of Ways located near the entrance to the tree lined avenue.
