Shaw House and Church Conservation Area Management Plan

A report by LUC and Keevil Heritage Limited

Final Report
March 2020

Client: West Berkshire Council

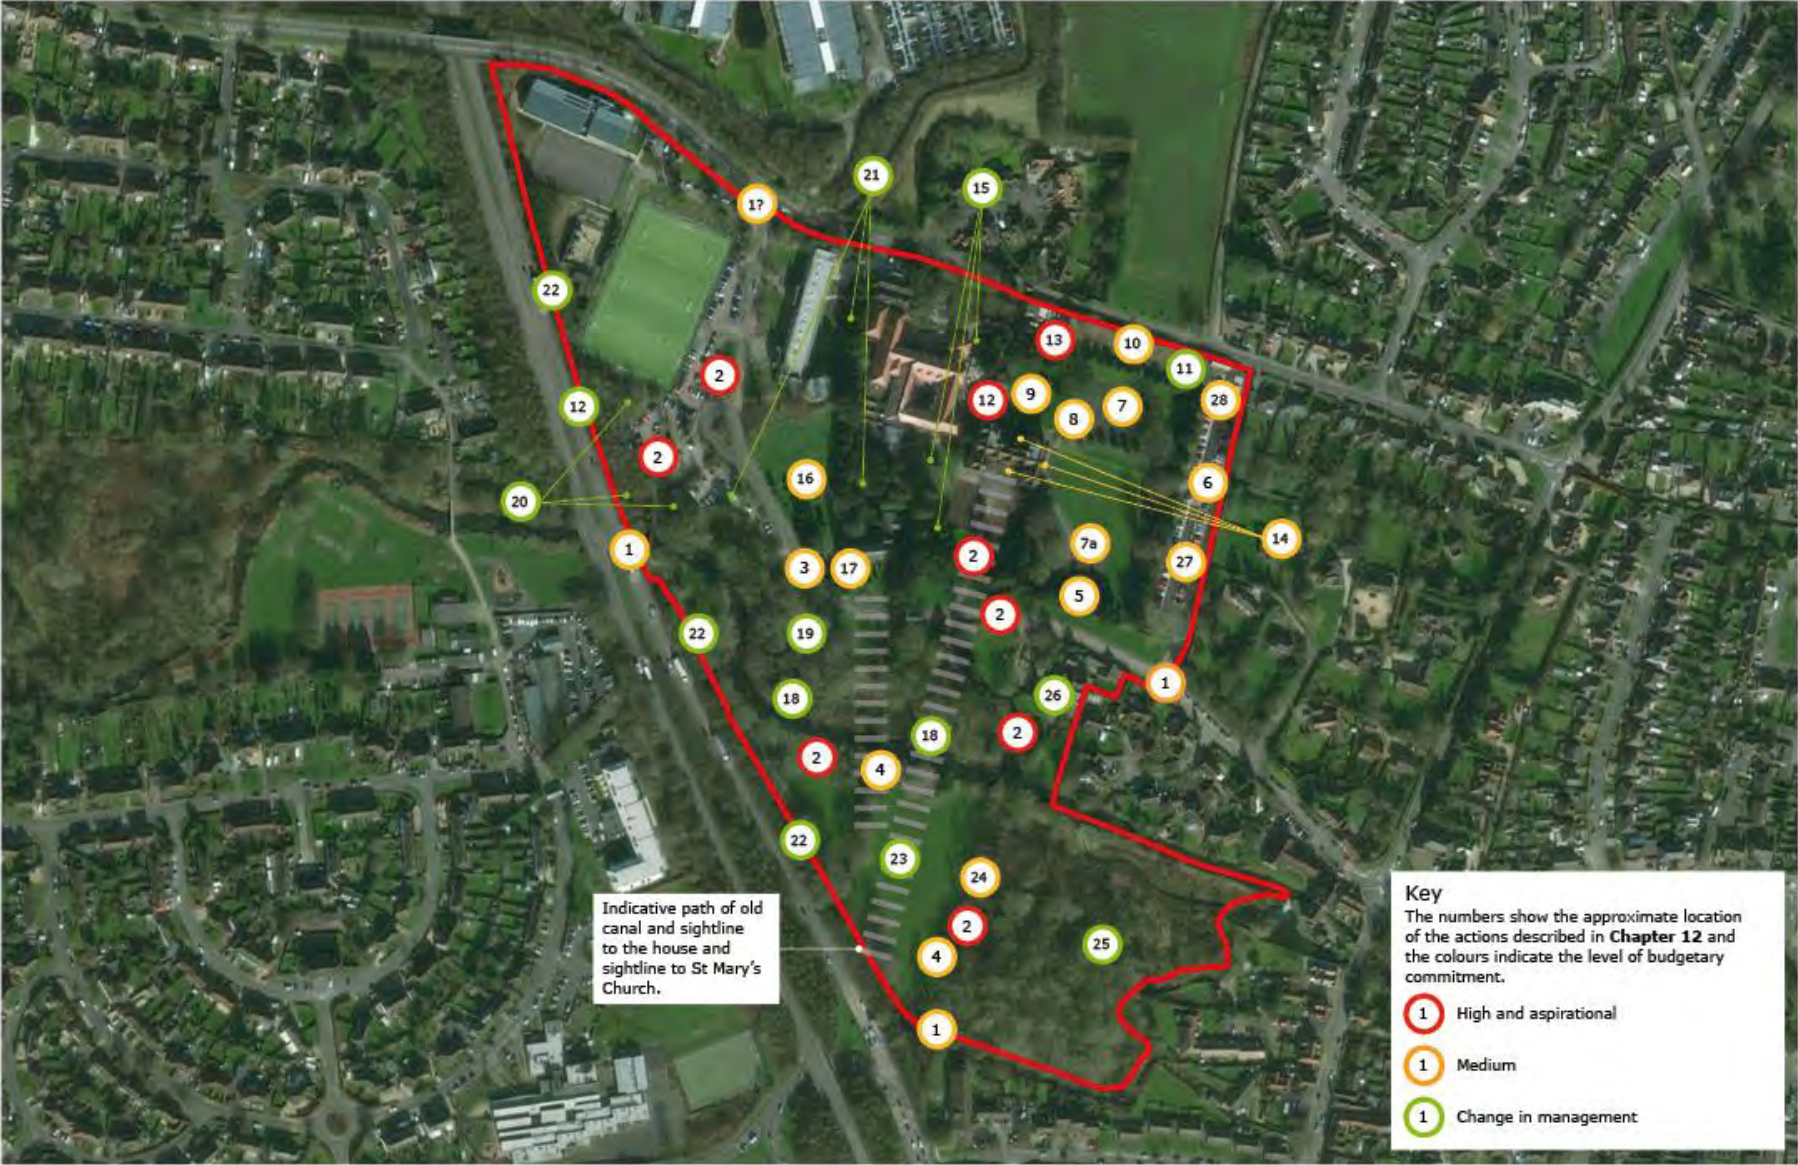
Figure 12.1 Masterplan Actions

- 12.6 The ID numbers in the following tables refer to the Masterplan, Figure 12.1 and show the approximate locations for the proposed actions or in the case of long (eg 2, Church Road) or widespread (eg 27, the new car park) features, points along or within the feature.

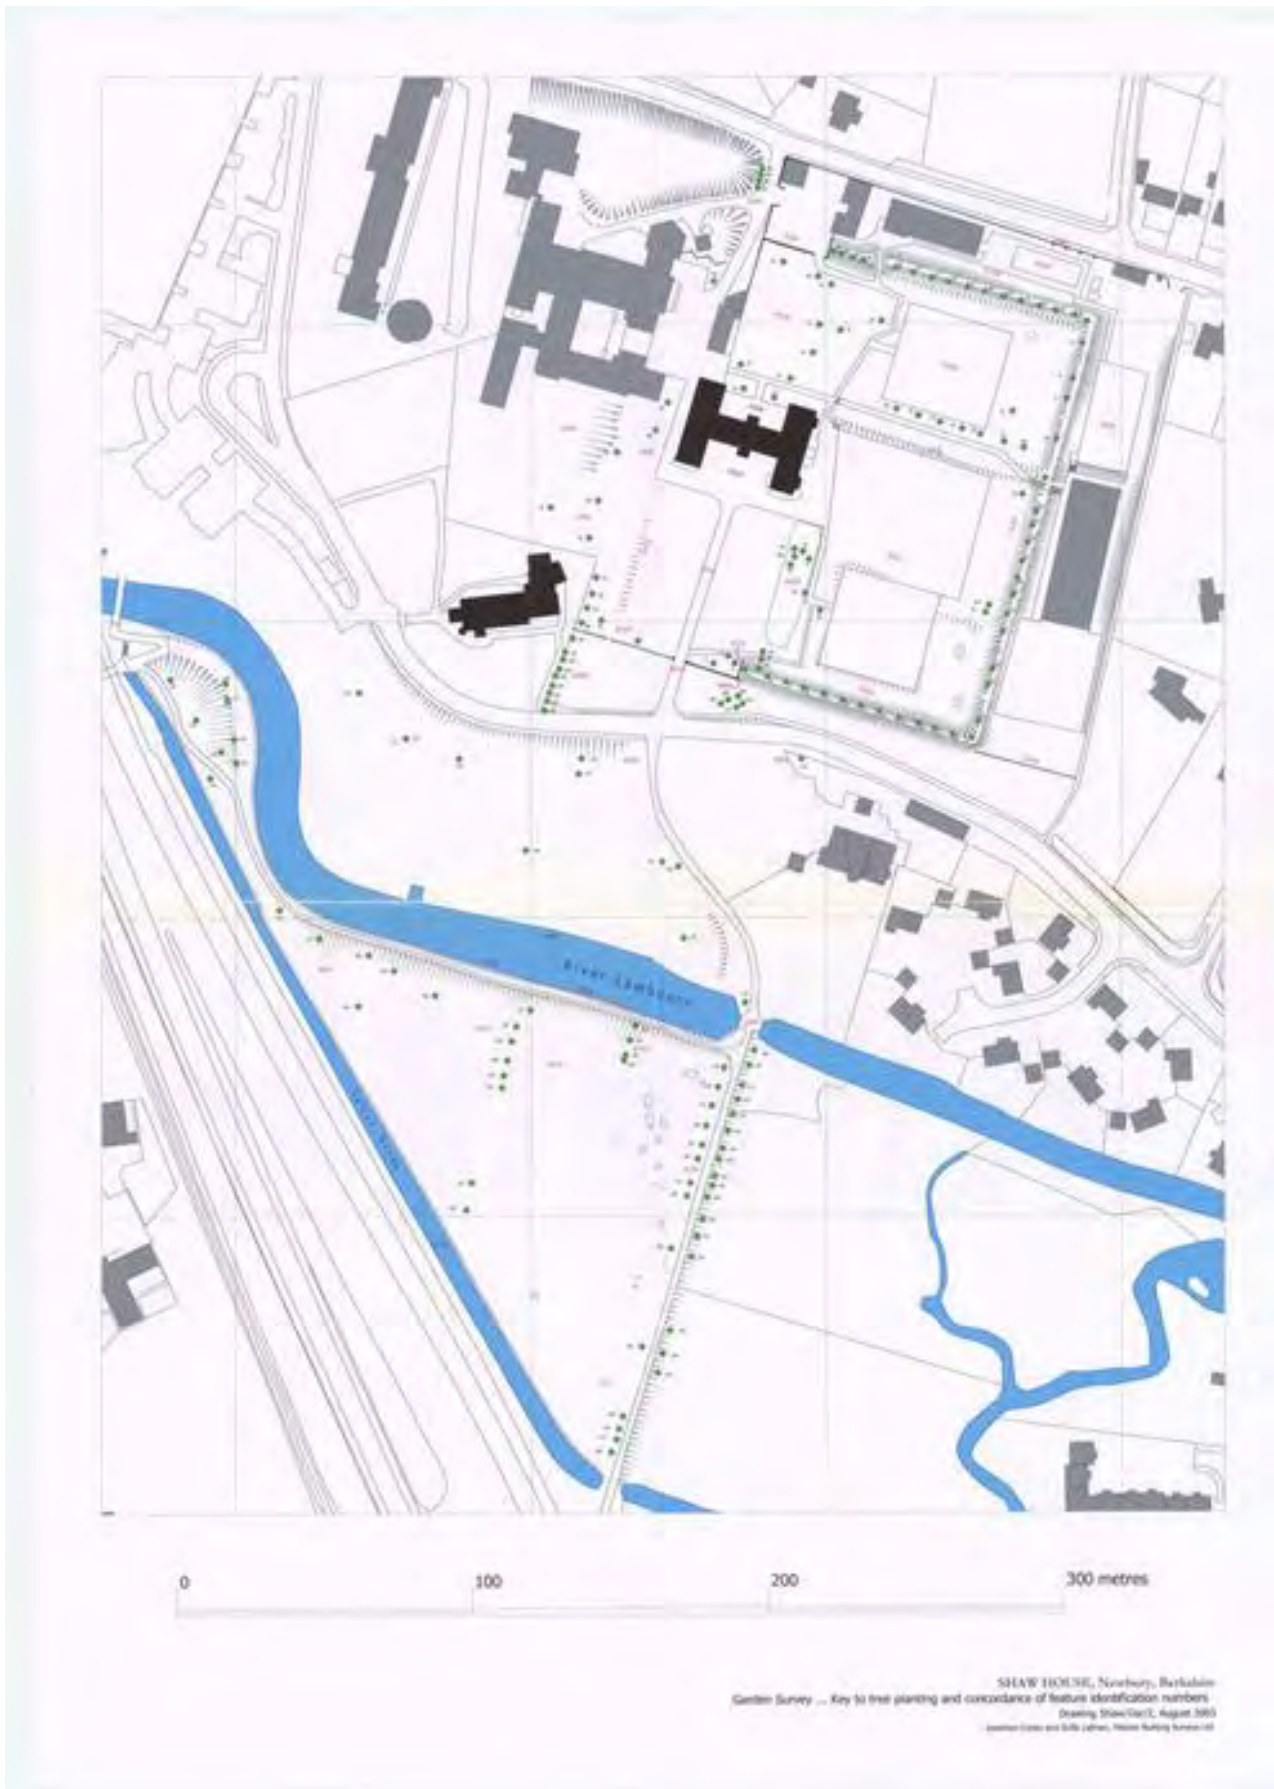
Figure A3.1 Trees surveyed in 2003

Area of Shaw House Garden	Tree No	Tree species	Latin Name	Note	Diameter at Breast Height (DBH), cm	Phase of Garden	Location/Description
							of the former canal
G/7/e	175	Ash	Fraxinus Excelsior		67	Phase VIII	Area to the west of the former canal
G/7/e	176	Ash	Fraxinus Excelsior		52	Phase VIII	Area to the west of the former canal
G/7/e	177	Ash	Fraxinus Excelsior		67	Phase VIII	Area to the west of the former canal
G/7/e	178	Ash	Fraxinus Excelsior		70	Phase VIII	Area to the west of the former canal
G/7/e	179	Ash	Fraxinus Excelsior		88	Phase VIII	Area to the west of the former canal
		Whitebeam	Sorbus Aria	Planted since 2003 survey		N/A	Great lawn, north-west corner near path
		Walnut	Juglans Regia (?)	Planted since 2003 survey		N/A	Great lawn, north-west corner near path

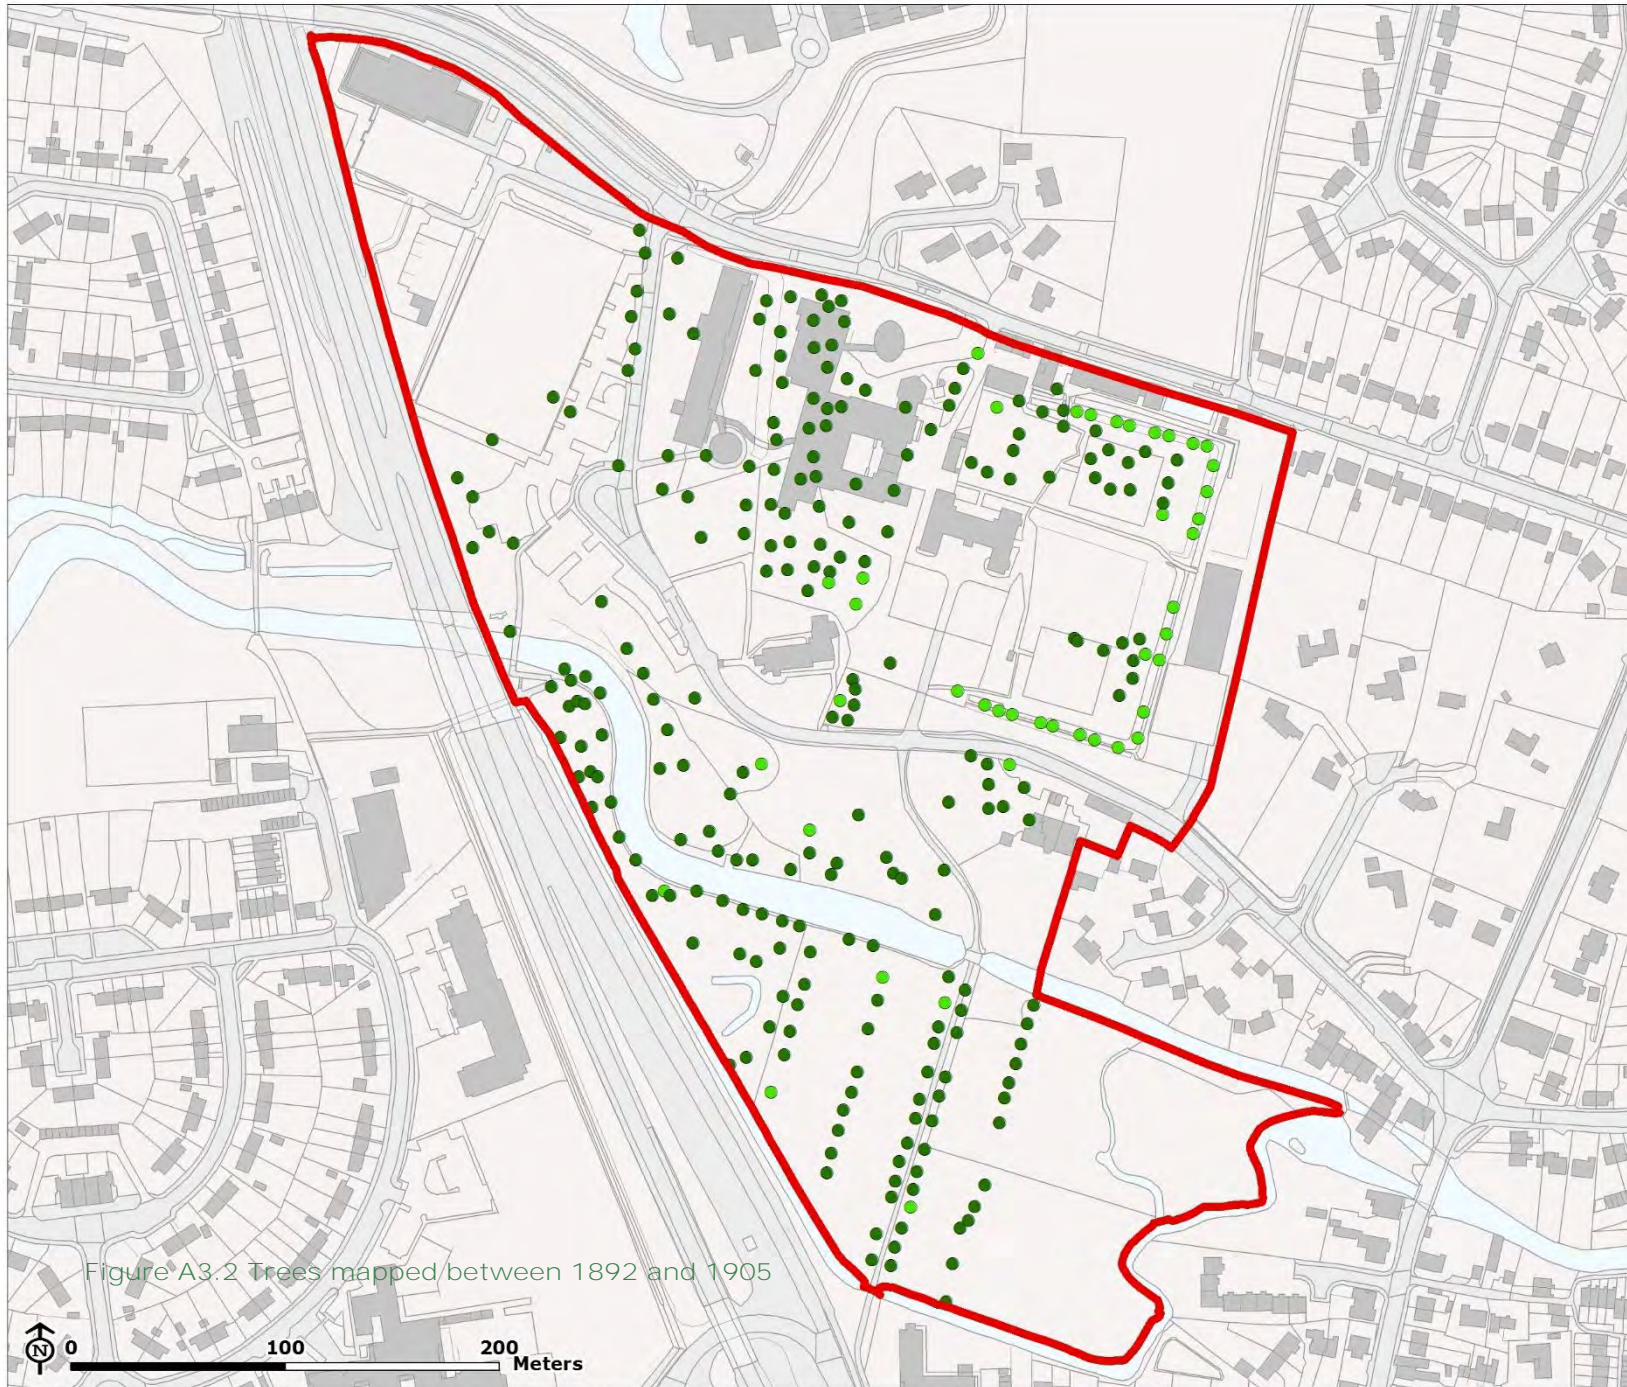
Figure A3.2 Trees mapped between 1892 and 1905

Trees Mapped Between
1892 and 1905
